MISCELLANEOUS PAPER CERC-92-10

ENGINEERING ASSESSMENT OF HYDRODYNAMICS AND JETTY SCOUR AT LITTLE RIVER INLET NORTH AND SOUTH CAROLINA

Final Report

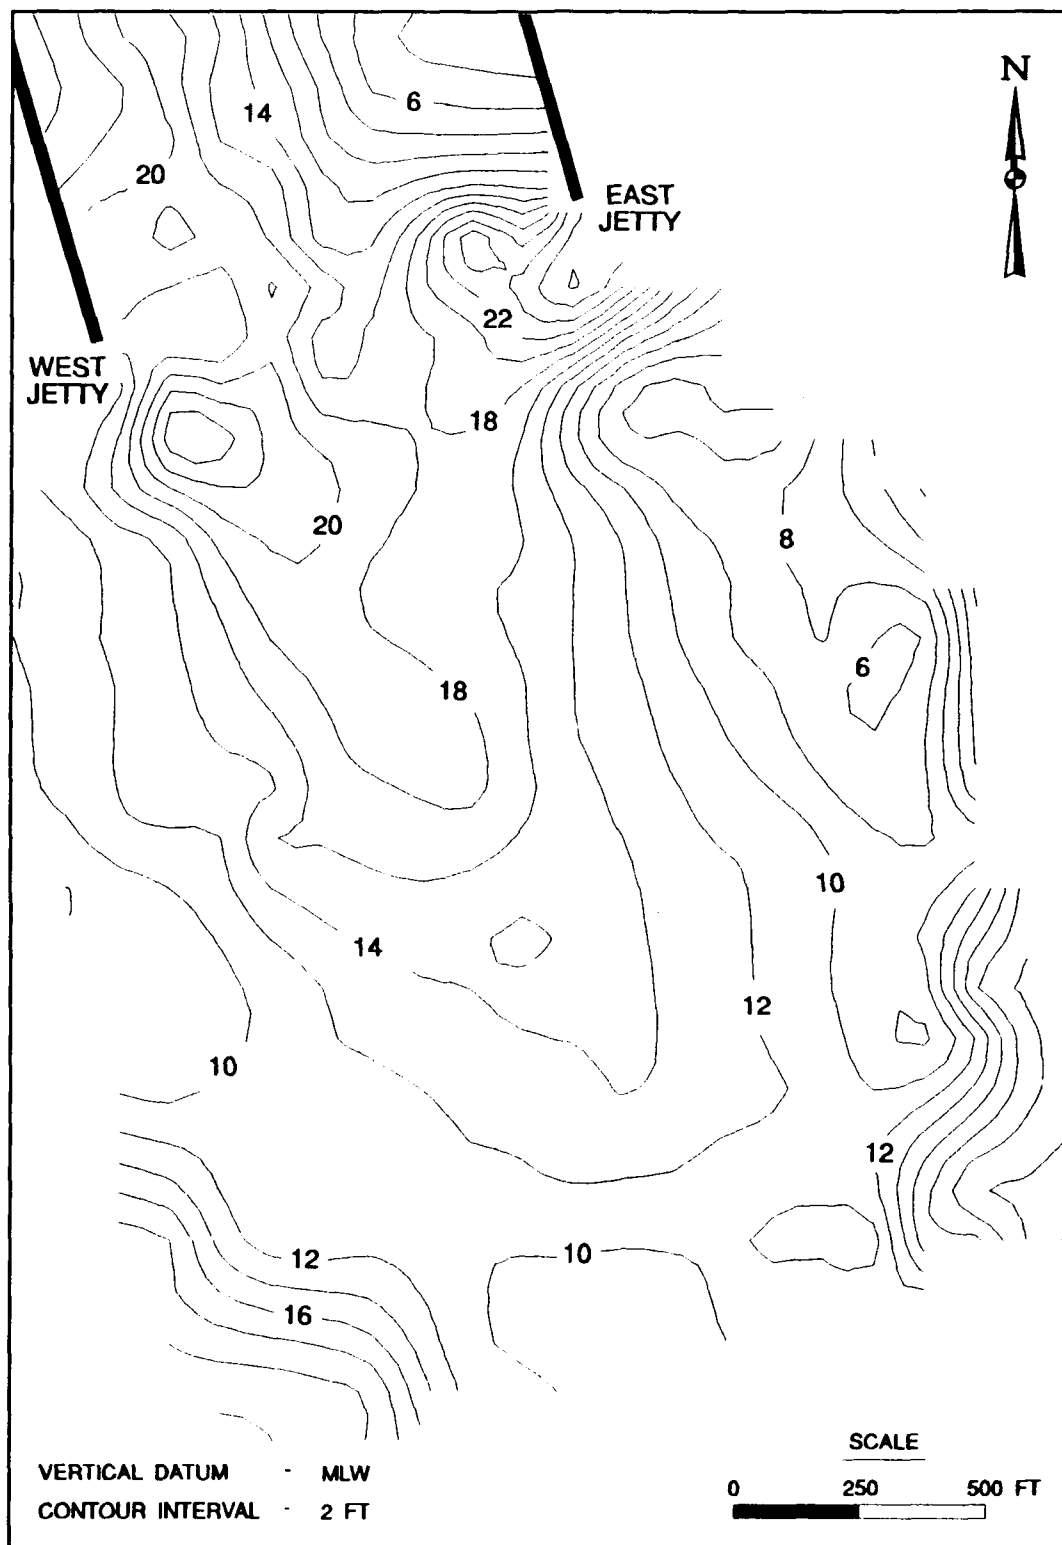
Figure 63. Ebb shoal morphology: July 1988

the tip of the east jetty and varies in depth between -5 and -12-ft MLW (Figures 61 and 63). The close proximity of the ebb shoal to the tip of the jetty also may be resulting in increased channelization of flood tidal flow through the scour hole.

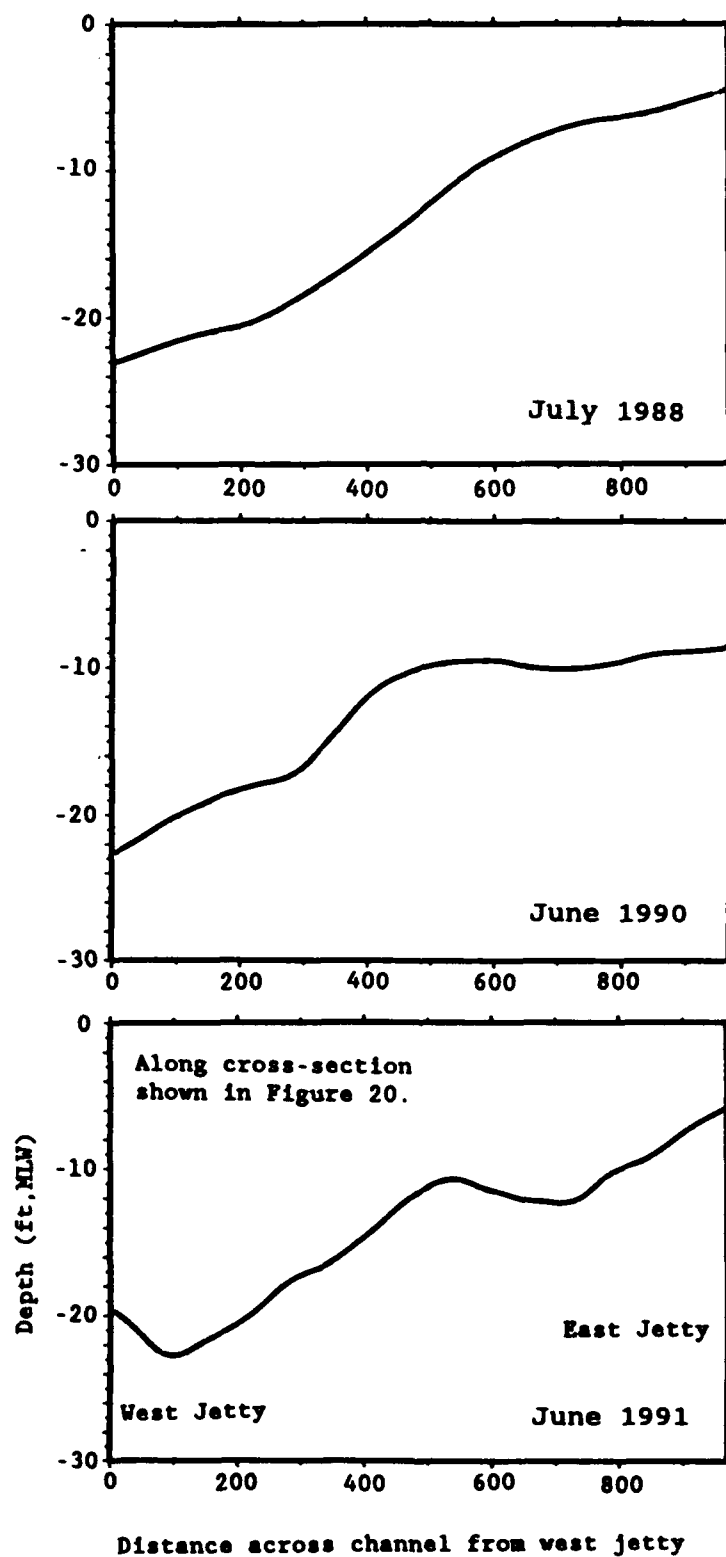
Figure 64. Inlet cross sections between jetties:
July 1988 to June 1991

- d. A rough cross-sectional slope analysis on a portion of the channel shows that the cross-channel slope is beginning to change and appears to be flattening across the inlet, thus becoming less steep towards the west jetty (Figure 64). The cross-sectional area analysis presented in Table 2 and Figure 20 also indicates that the inlet cross-section in that particular location is increasing, especially since the post-Hugo survey. These increases in area are relatively small; however, they do indicate that the inlet has not yet reached a long-term equilibrium condition.

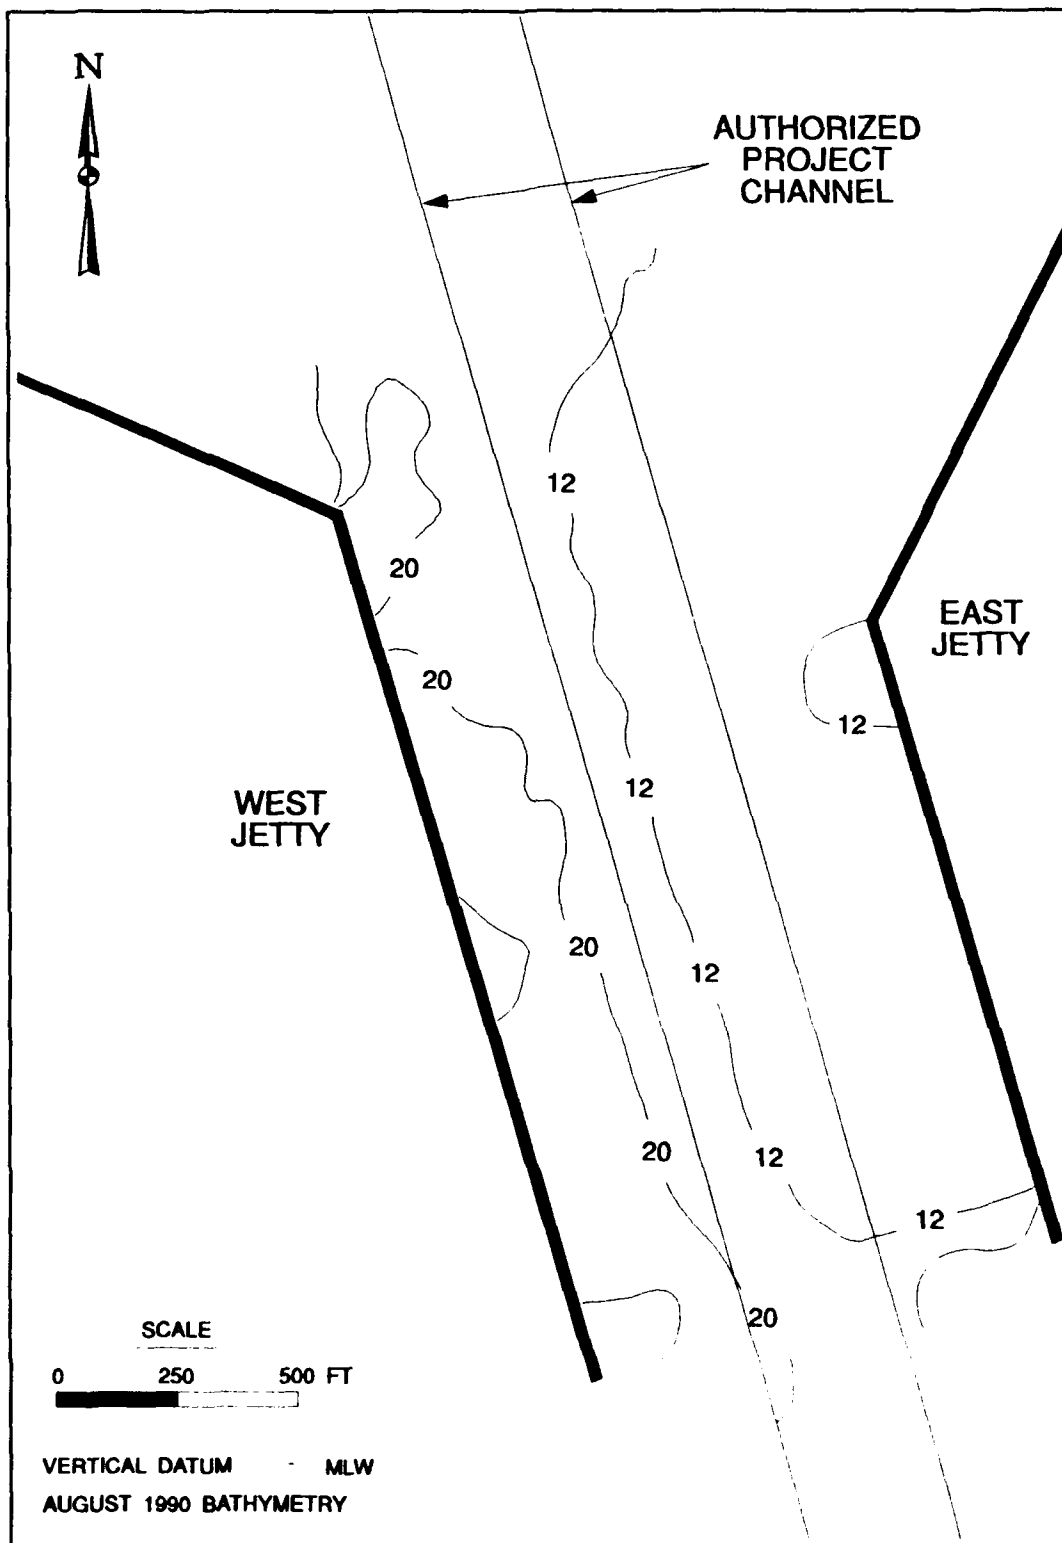
Figure 65. Authorized project channel and relative depths:
August 1990
